Alfonso Caballero de Rodas

Broken tooth #15. The fracture is subcrestal, and the tooth cannot be restored

Tooth extraction and immediate implant placement with immediate loading

Nobel Biocare N1™ Implant with immediate placement in a fresh extraction socket. Atraumatic tooth extraction with immediate implant in a palatal position, then immediate loading using a temporary abutment screwed to the implant.

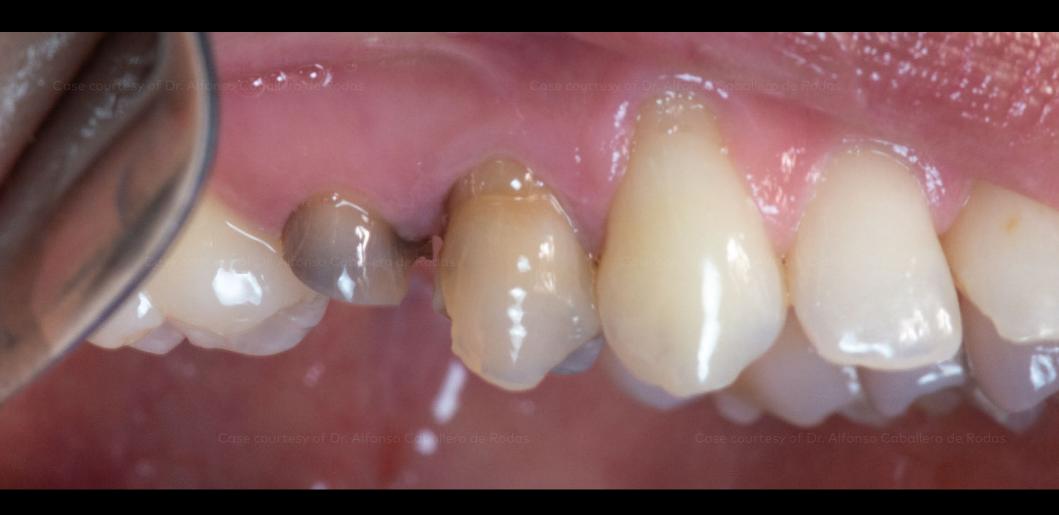
Situation before the surgery with a visible fracture of tooth #15

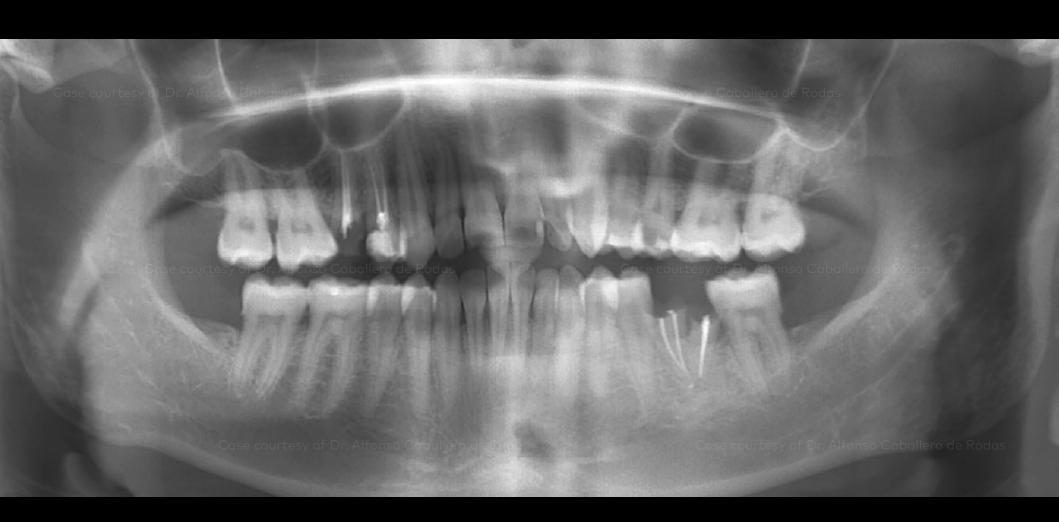
Radiographic image at presentation showing crown fracture on tooth #15

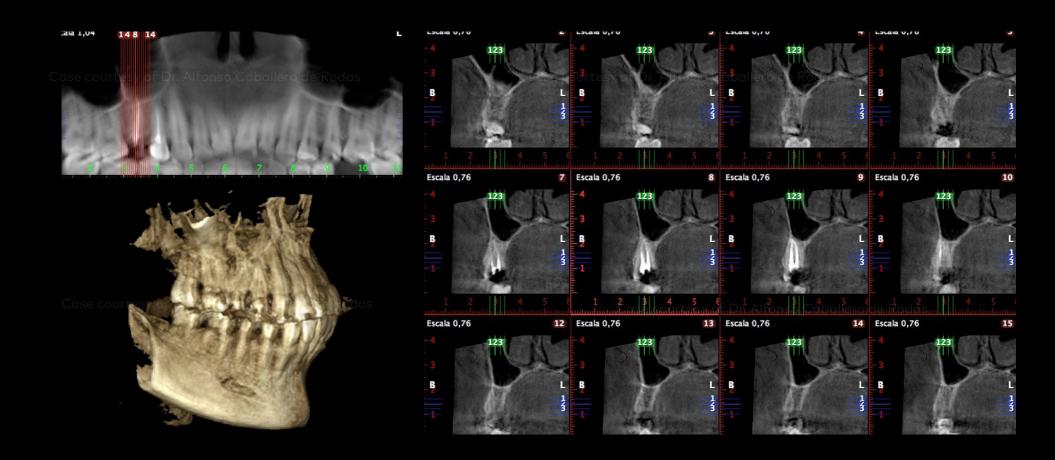
CBCT maxilla. Good bone foundation in 3 dimensions. No infections

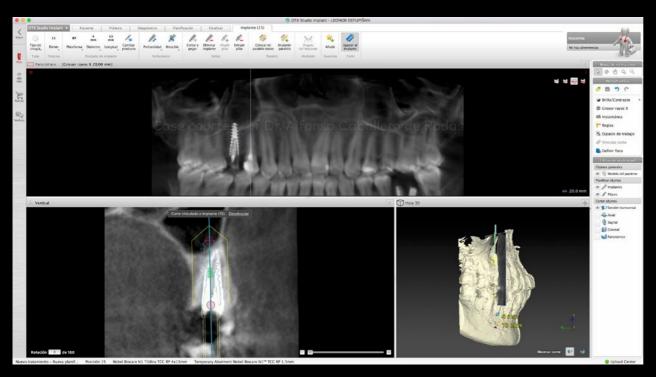
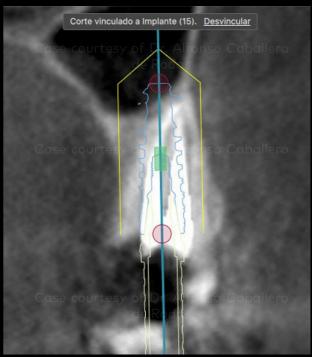
Digital treatment planning in DTX Studio™ Implant – 13 mm implant and temporary abutment

DTX Studio™ Implant report:

- Nobel Biocare N1™ TiUltra™ TCC RP 4 x 13 mm
- Temporary Abutment Nobel Biocare N1™ TCC RP 1.5 mm

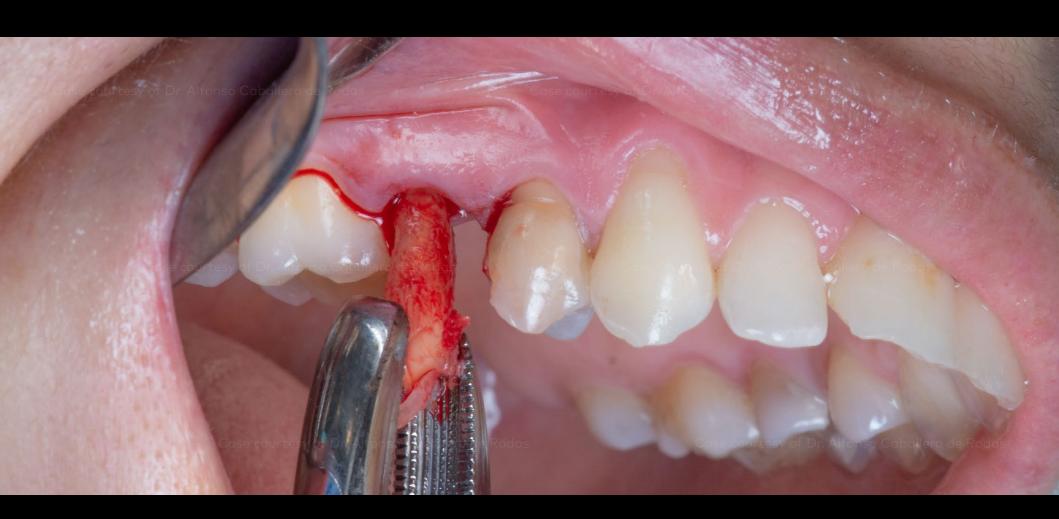
Atraumatic tooth extraction

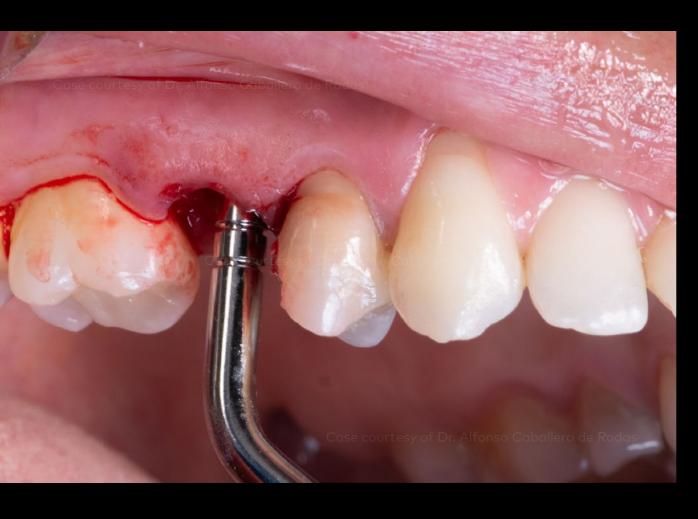
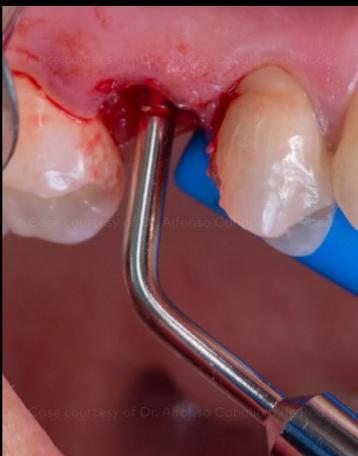
Verification of the extraction socket depth – confirmed 15 mm, sufficient to place the 13 mm implant

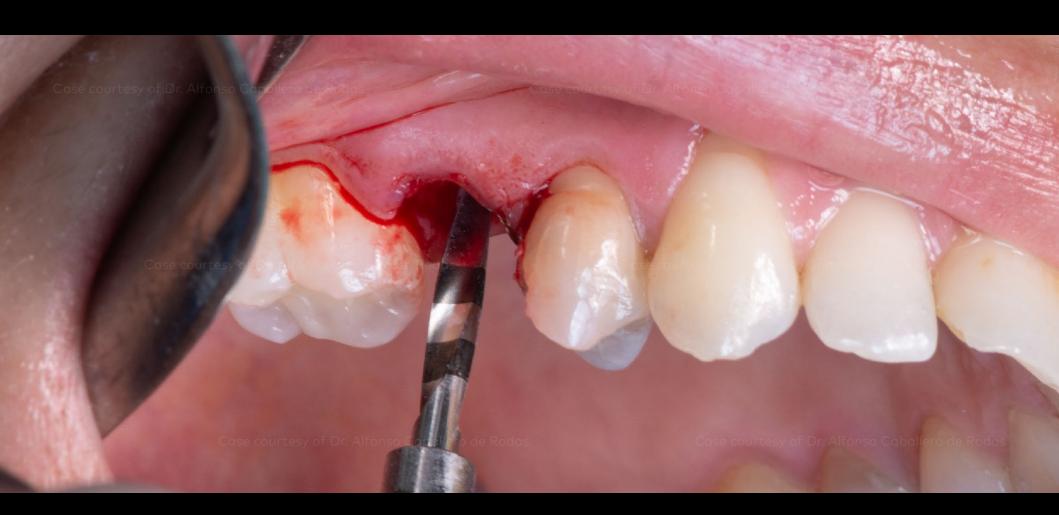
First step in site preparation: The OsseoDirector™ instrument defines final implant position

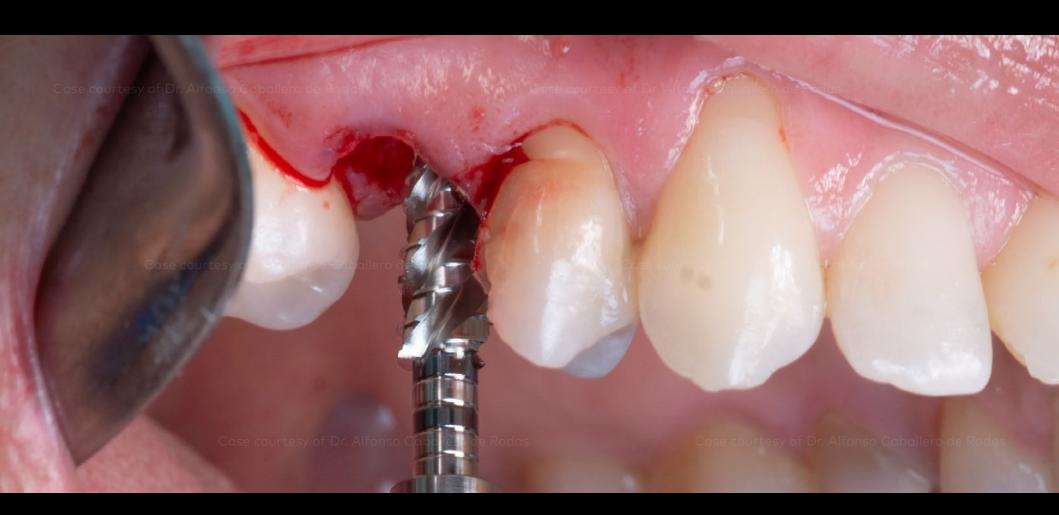
Second step: The OsseoShaper™ instrument operates at low speed 50 rpm and without irrigation. It creates a specific osteotomy for the co-packed Nobel Biocare N1™ Implant

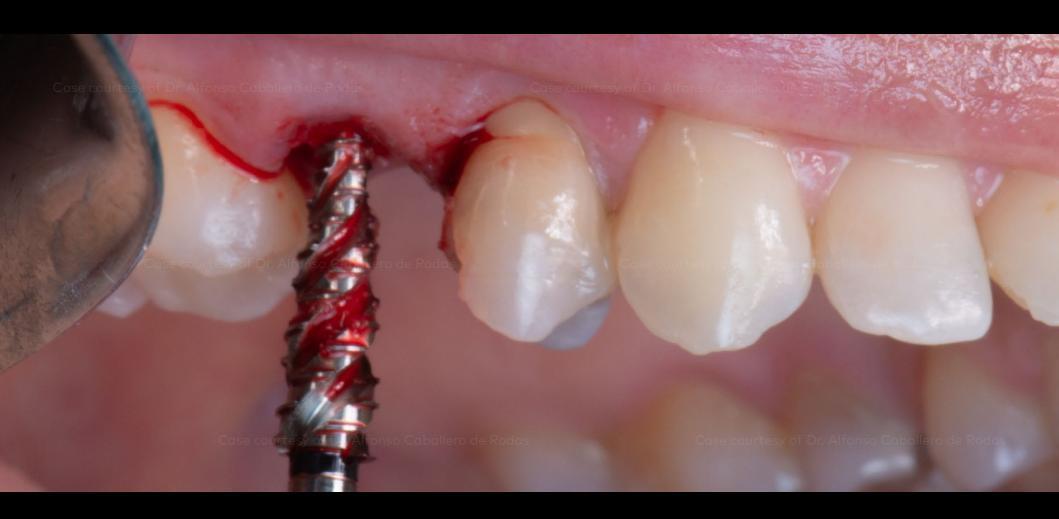
View of the OsseoShaper  $^{\mathsf{TM}}$  instrument freshly removed from the site

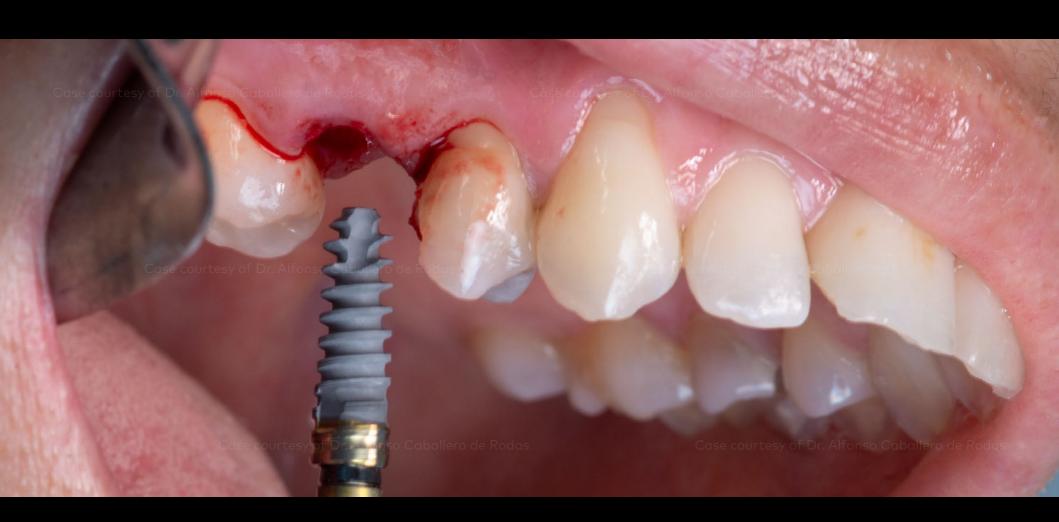
Nobel Biocare N1™ Implant featuring the TiUltra™ surface

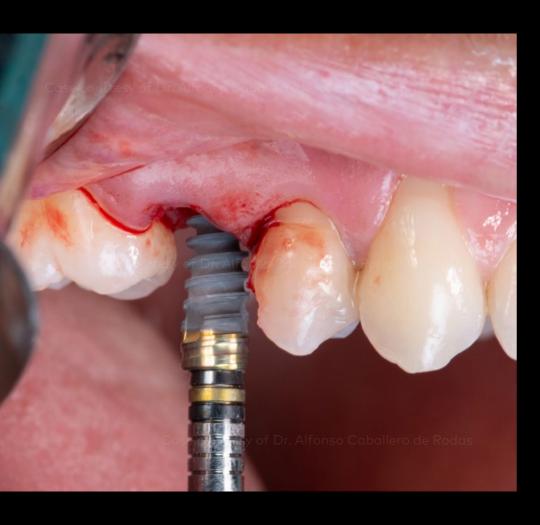
Nobel Biocare N1™ Implant placement

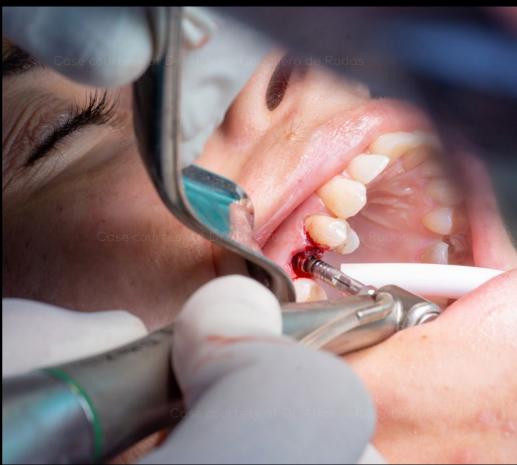
Nobel Biocare N1™ Implant insertion

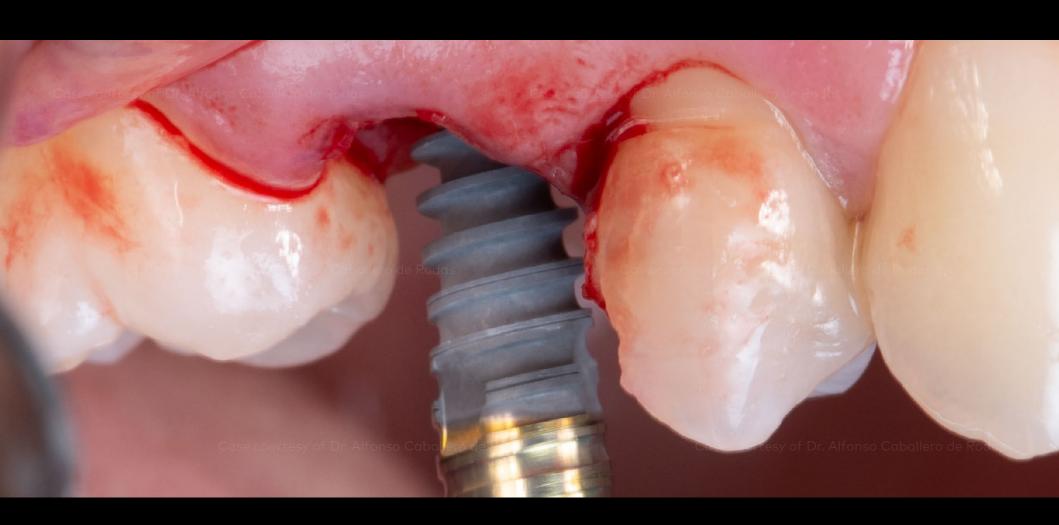
The Nobel Biocare N1™ Implant being placed in a fresh extraction socket

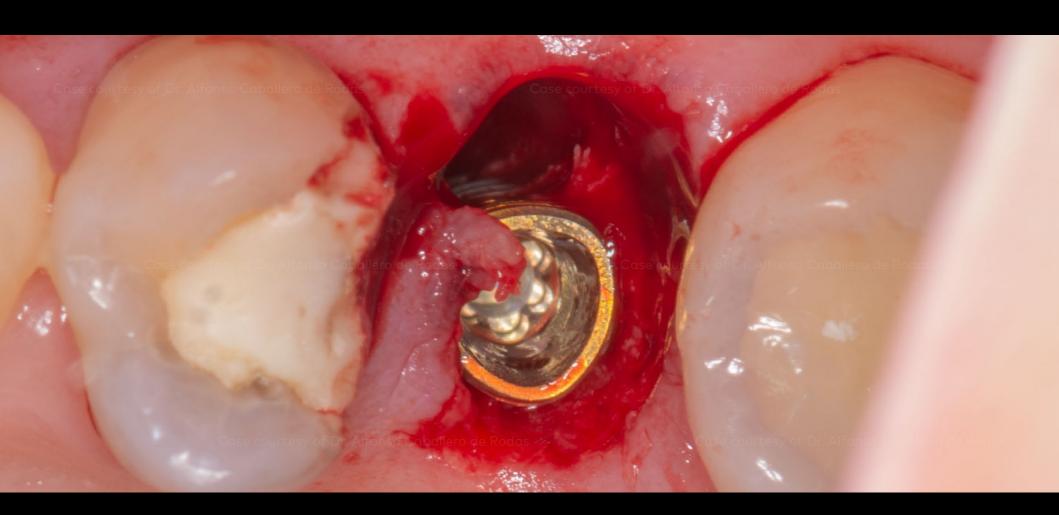
Occlusal view of the final implant position – flat side of the trioval conical connection (TCC) oriented towards buccal

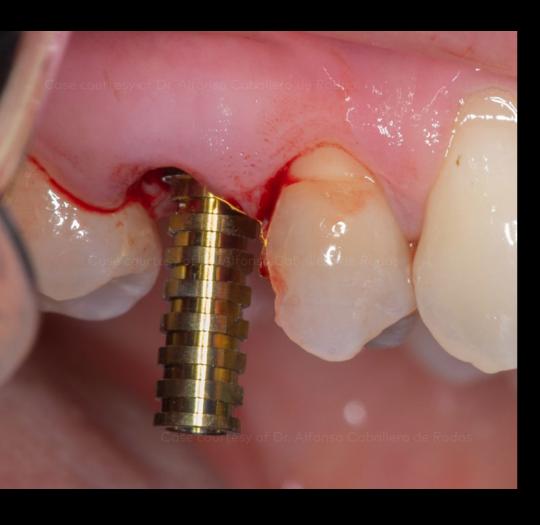
Temporary Abutment TCC 1.5 mm connected directly to the implant

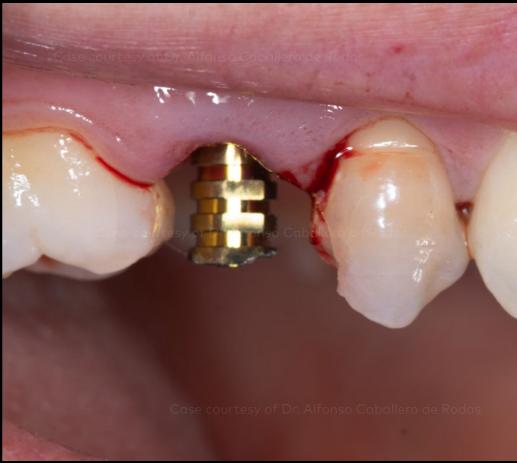
Temporary Abutment post reduced to the required height

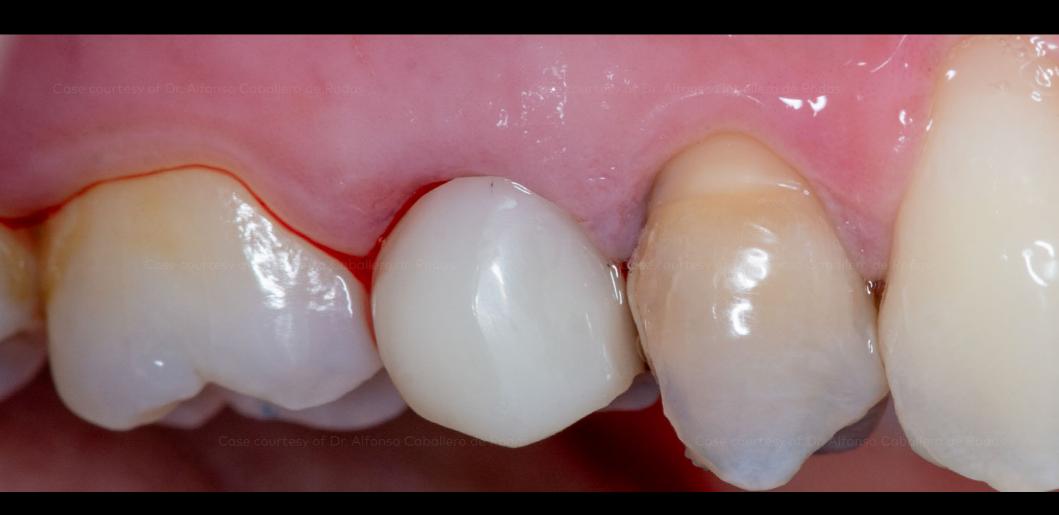
Provisional restoration in place after occlusal clearance check

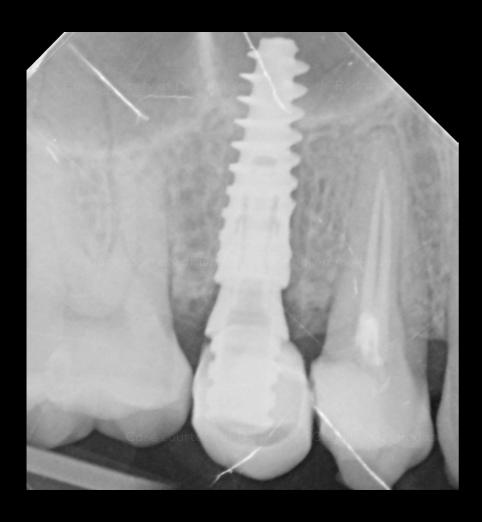
$\ensuremath{\mathsf{X}}\text{-ray}$  of the implant with the provisional restoration at the day of surgery

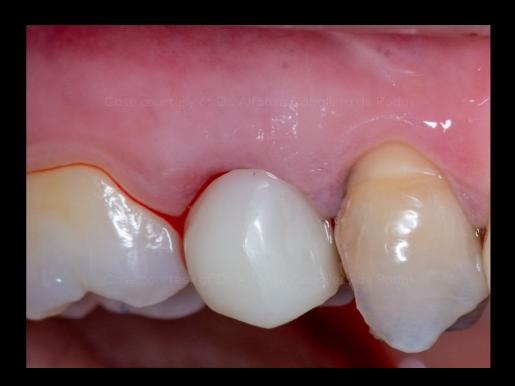
Provisional restoration at the day of surgery

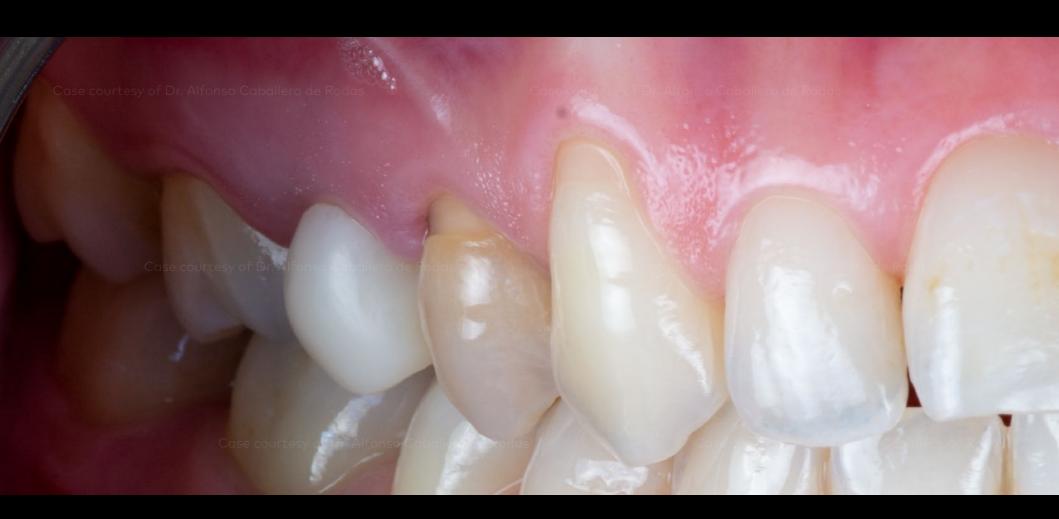
Lateral view 2 weeks post surgery. Tissue margin is stable

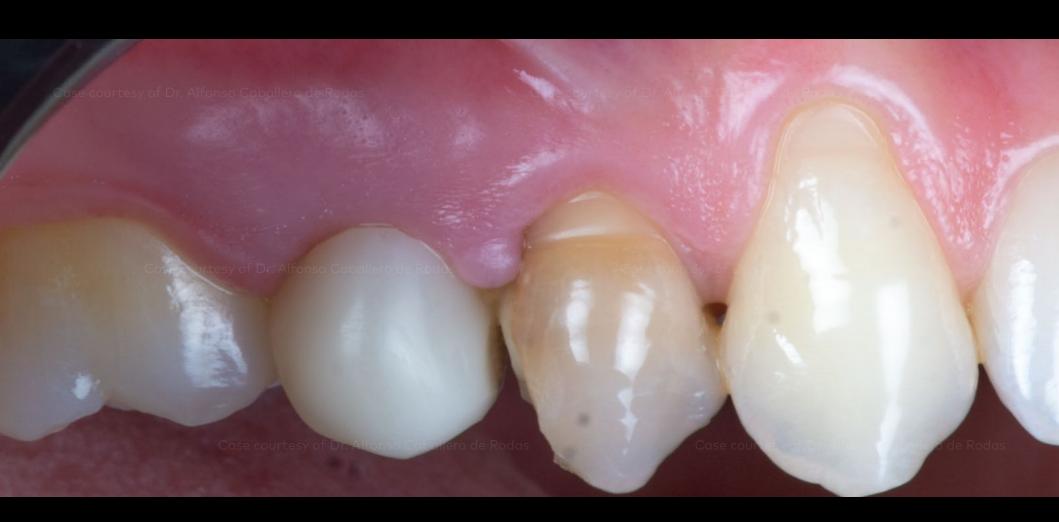
Tissue healing. We can see how transeptal fibers are healed and stable
