Immediate implant placement in a site with severe buccal dehiscence

Ferdinando D'Avenia
Italy

Chronic periodontitis.
Tooth # 25 with porcelain fused to metal crown and metal post and core. Vertical root fracture occurred two months earlier. 10 mm "U" shaped buccal dehiscence.

Immediate implant placement (NobelParallel CC RP 4.3 x 13 mm) in combination with a GBR procedure (using creos xenogain and creos xenoprotect).

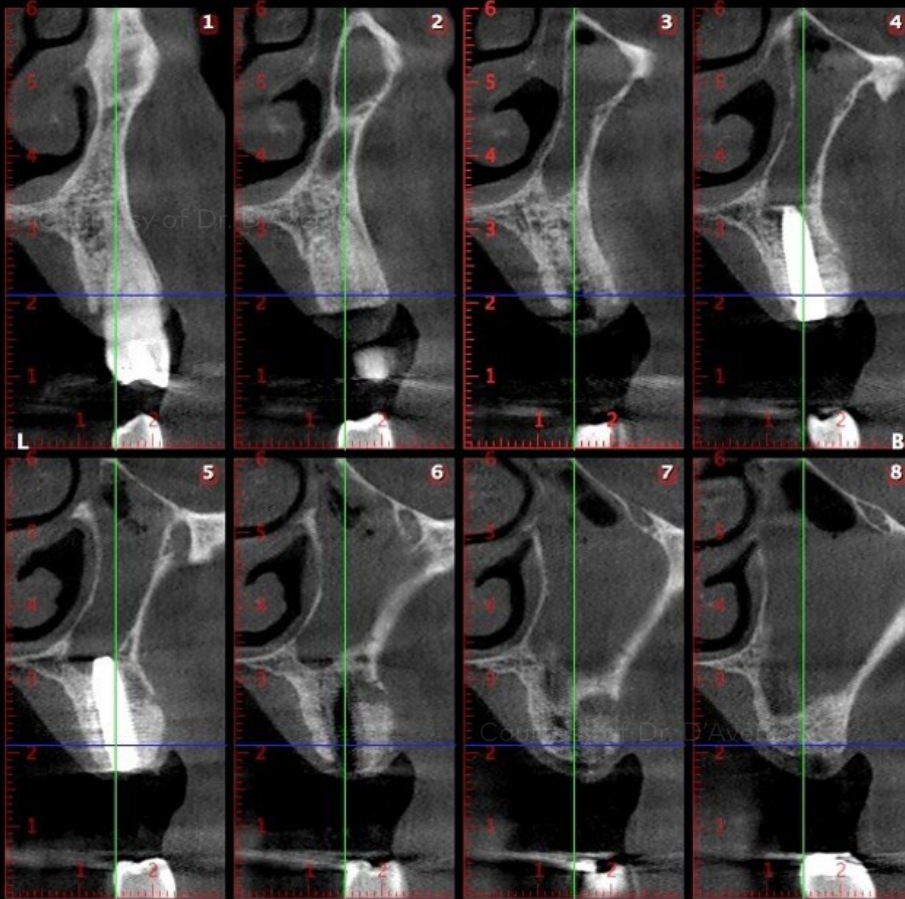
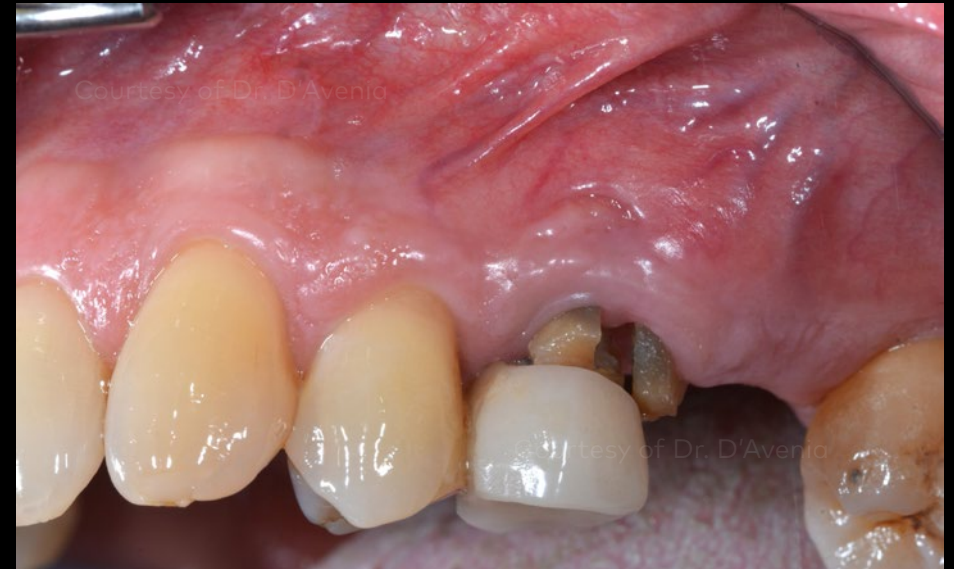
Initial situation: pre-operative CBCT images.

Clinical pre-surgical situation.

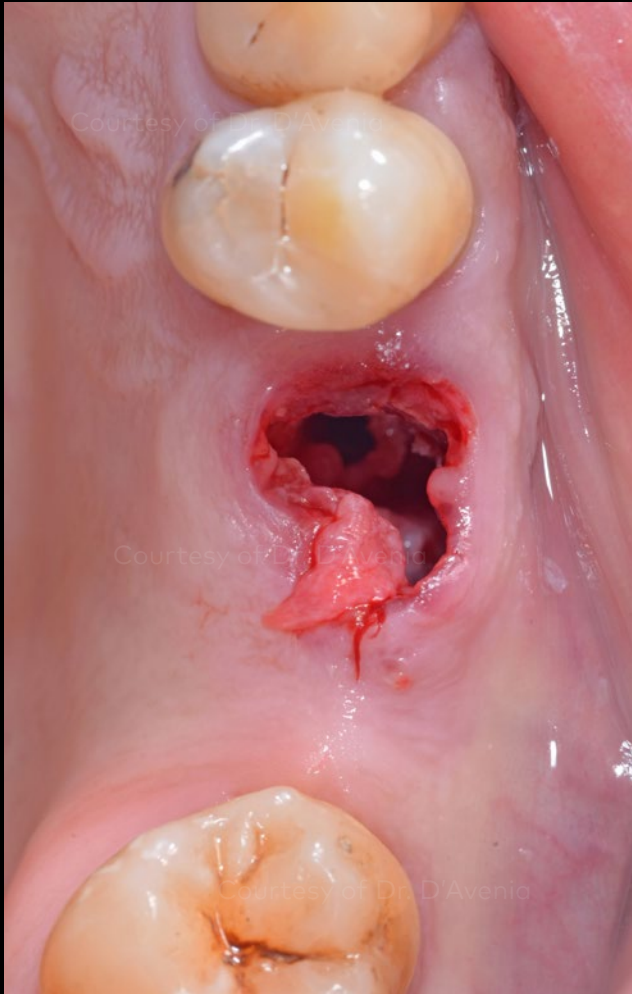
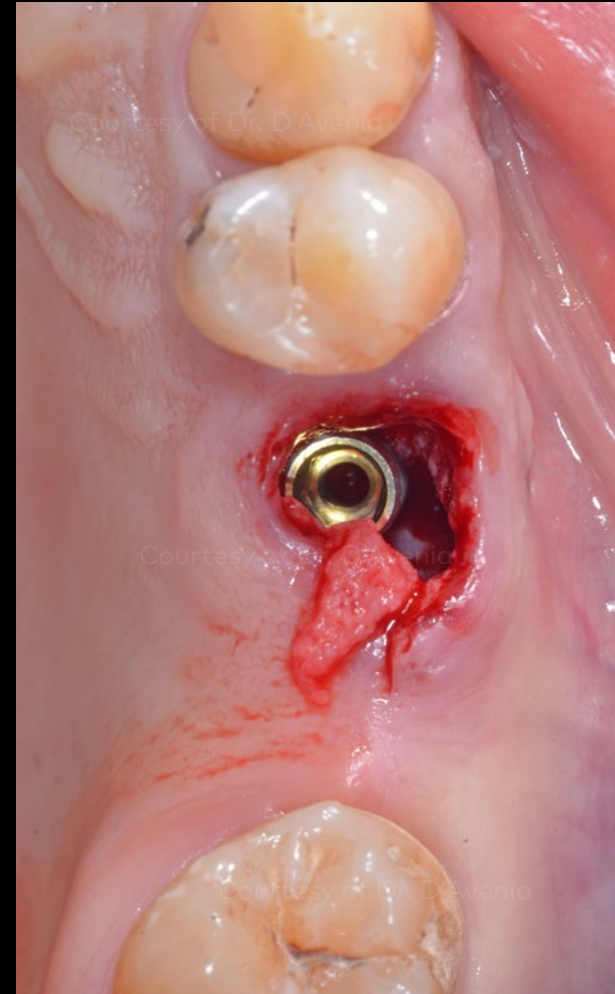
After atraumatic tooth extraction, the granulation tissue is completely removed. The osteotomy is prosthetically driven, in order to provide a second premolar screw retained restoration with an occlusal screw access hole. In order to satisfy this criteria, the implant is more favorably housed in predominantly native bone, mesio-lingually to the center of the defect.

The implant (NobelParallel CC RP 4.3 x 13 mm) is placed with 20 Ncm insertion torque, with buccal threads exposed to the defect area (without bone contact).

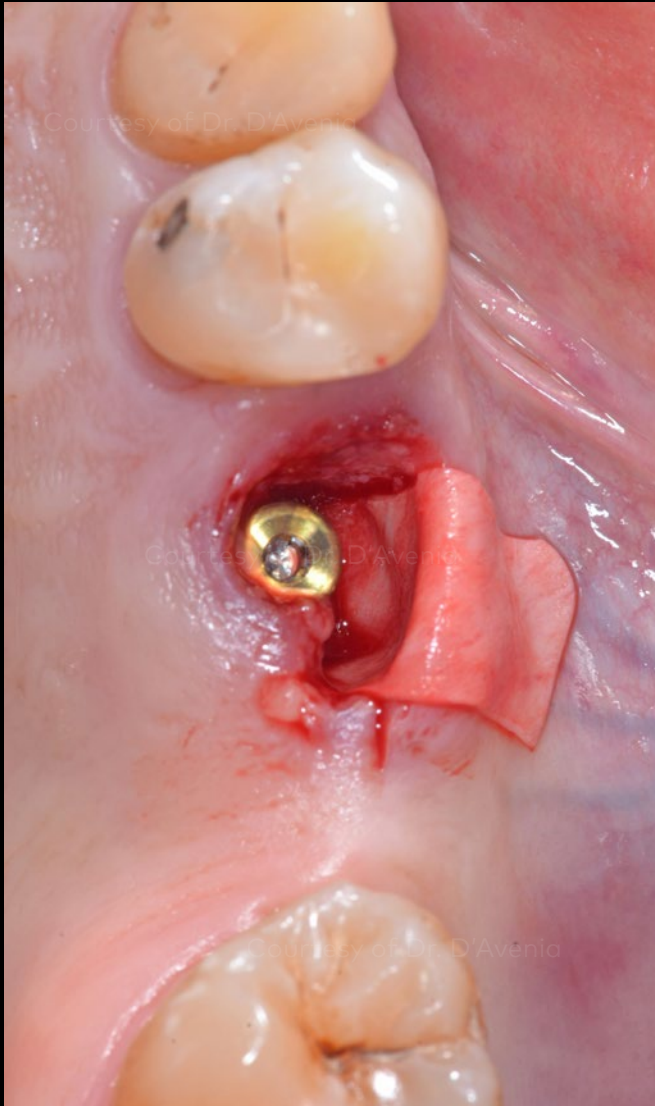
Placement of creos xenoprotect inside the extraction socket to protect creos xenogain from exposure to the soft tissue through dehiscence.

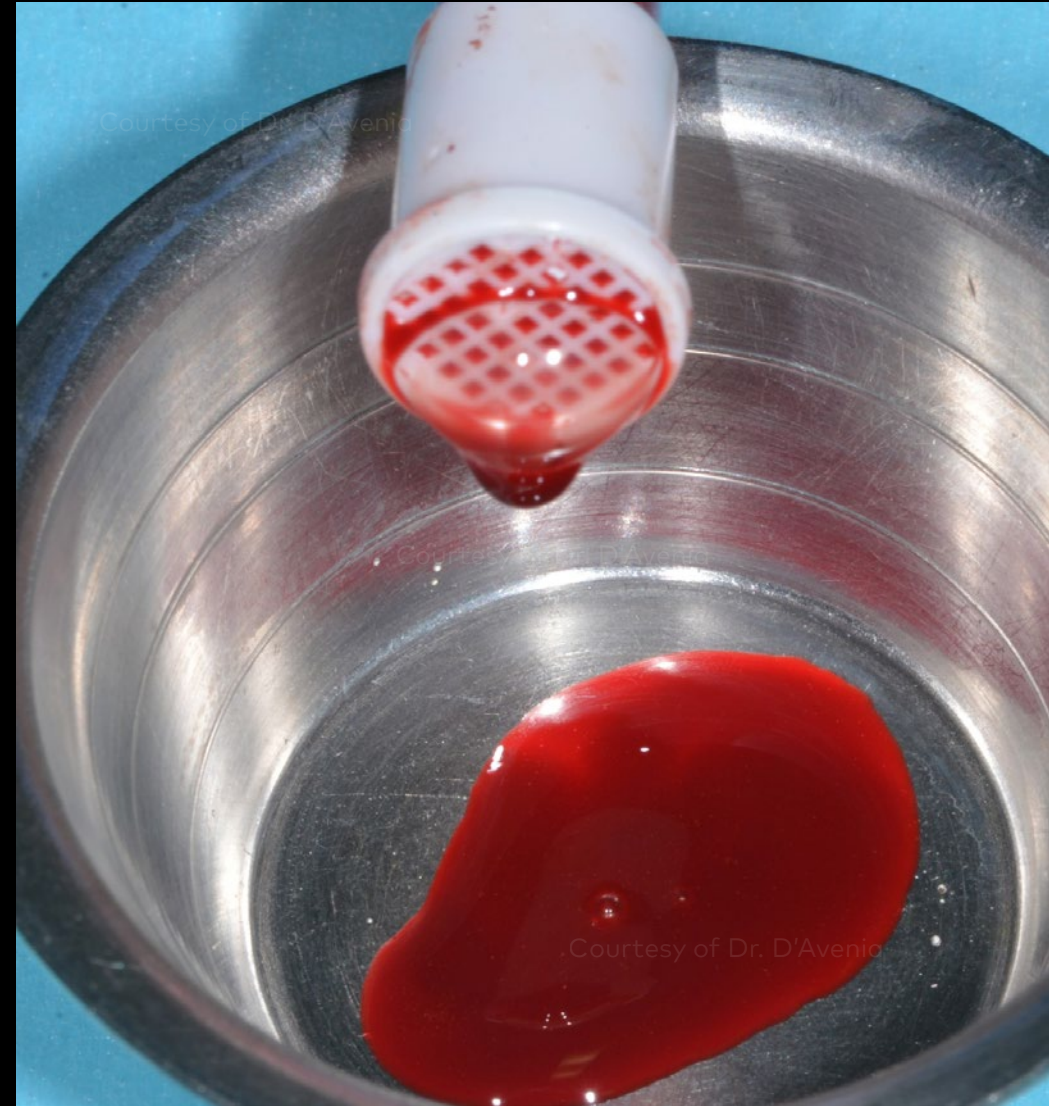
Hydration of creos xenogain with venous blood.

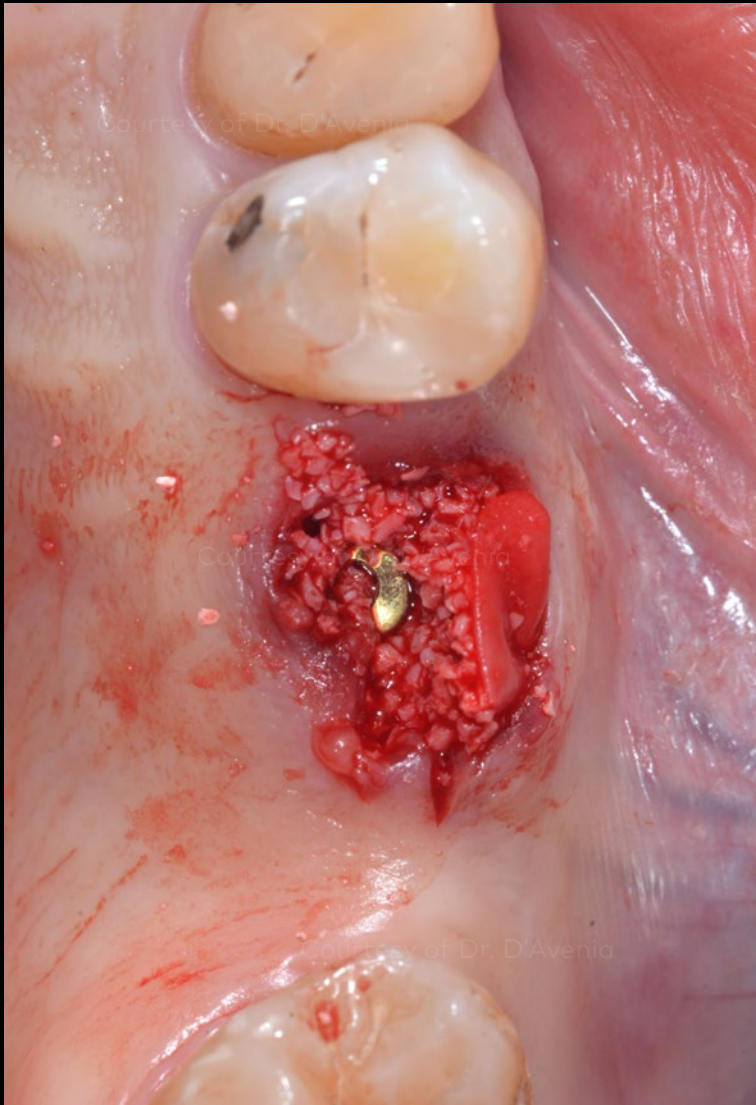
Placement of creos xenogain into the bony defect.
The implant is covered with a 3 mm healing abutment (Ø 3.6 mm).

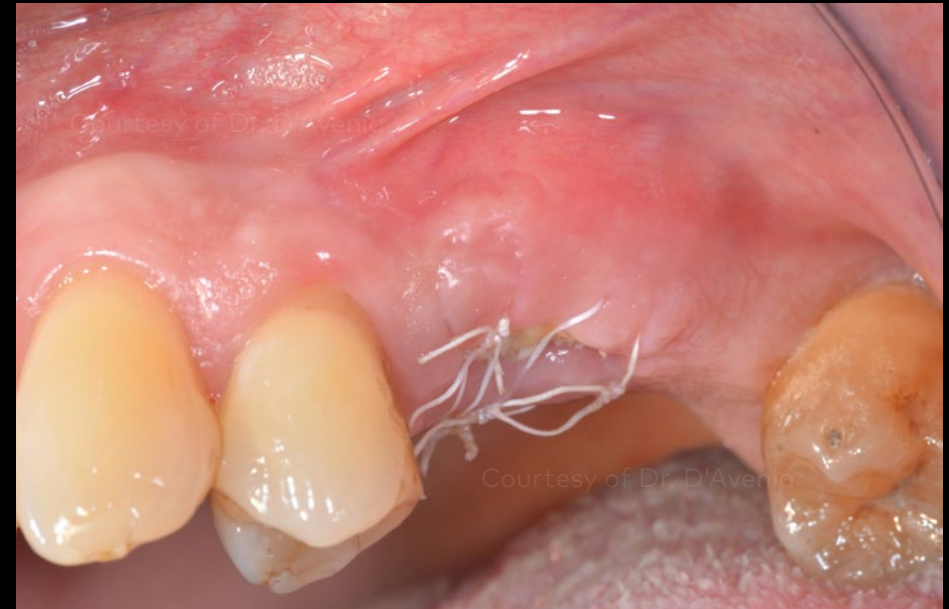
Healing after 8 days with slight membrane exposure.

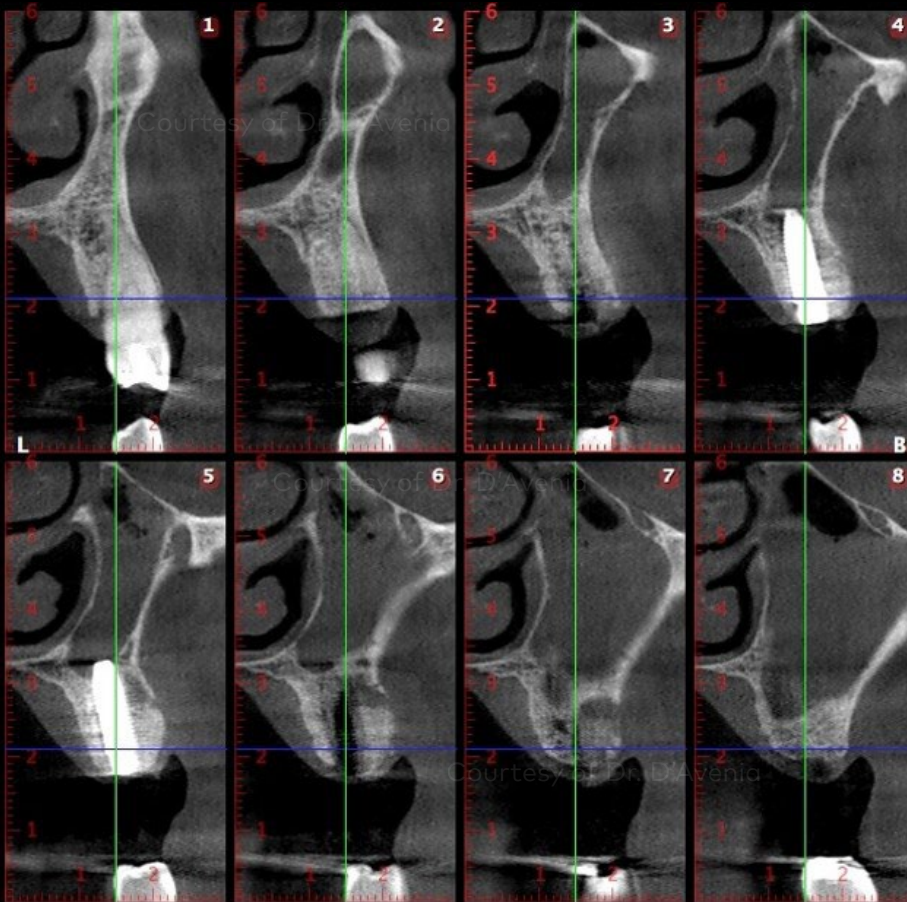
Post-operative CBCT showing sufficient bone augmentation of the buccal wall dehiscence.

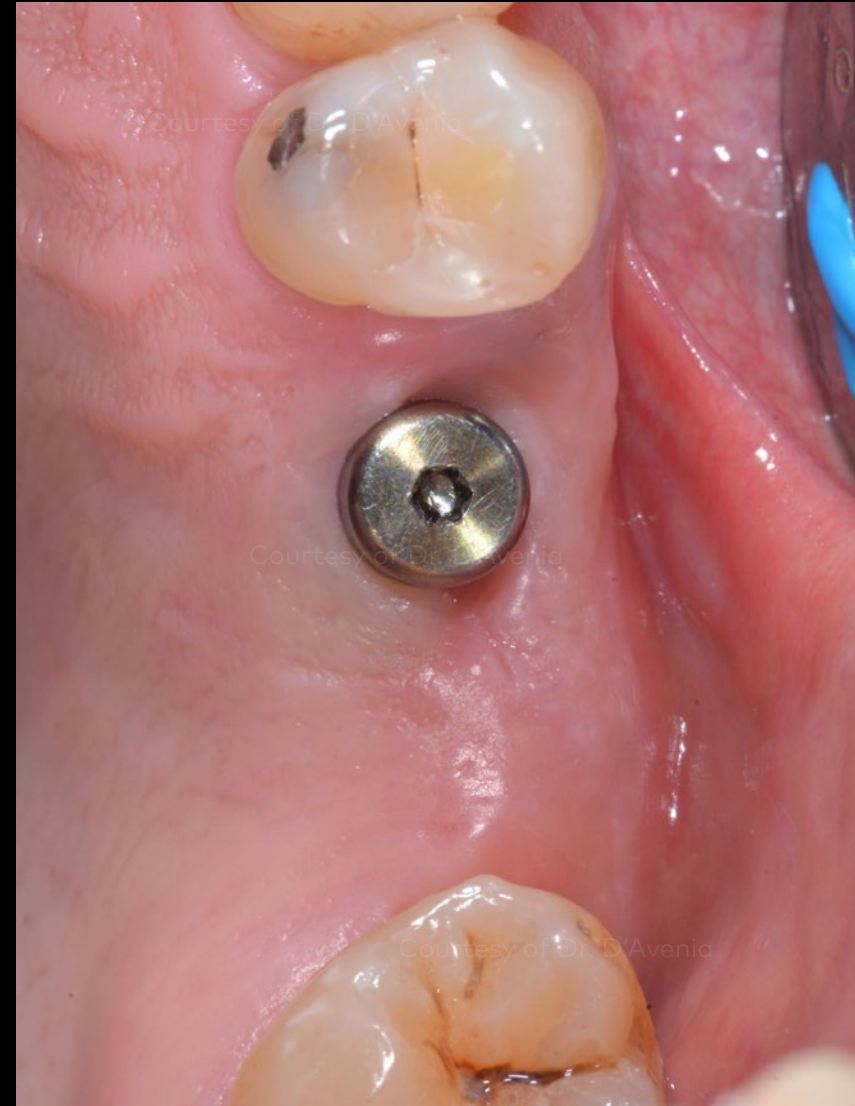
120 day follow-up: during the final impression visit, the healing abutment is changed. A wider diameter allows a better management of the final restoration emergency profile.

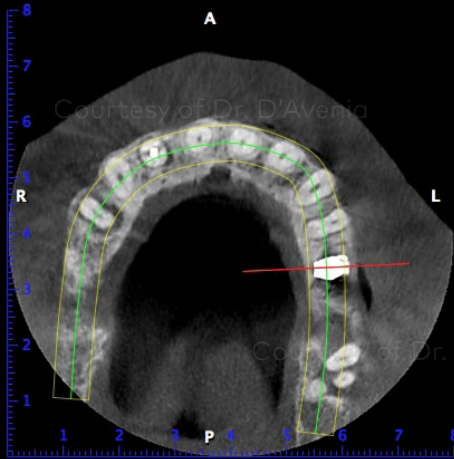
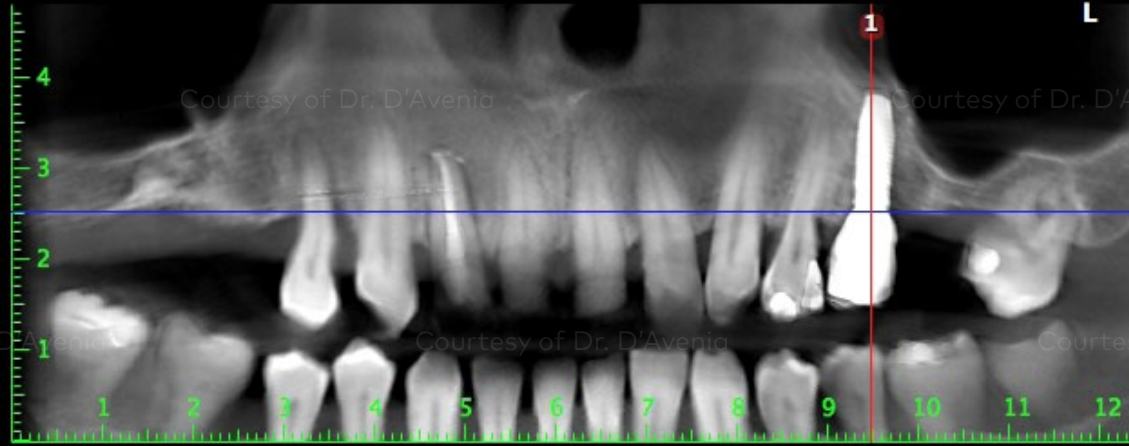
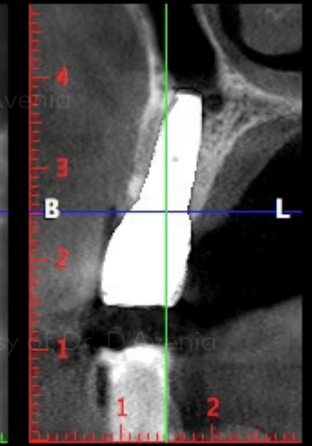
CBCT after healing.

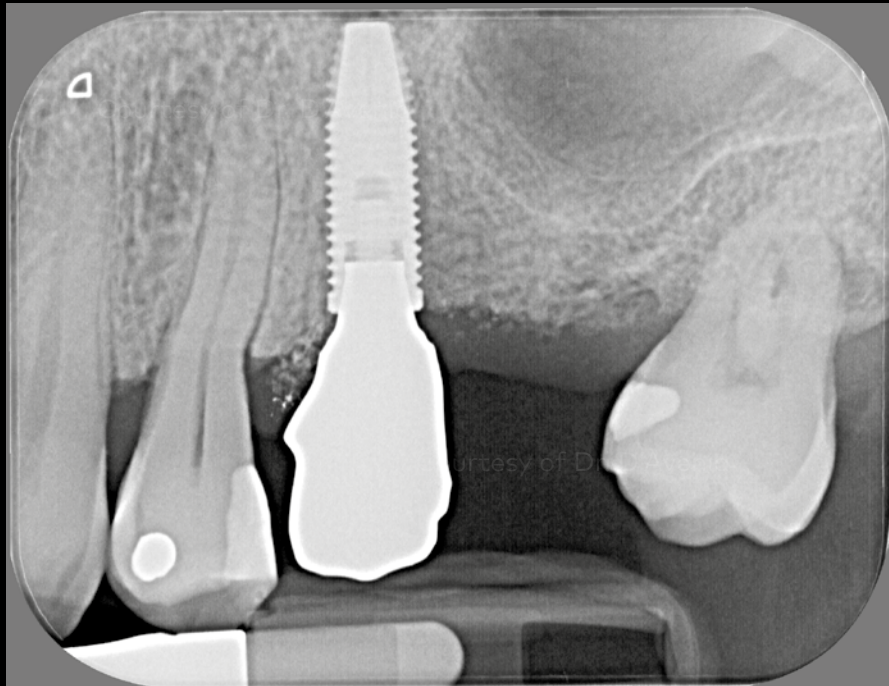
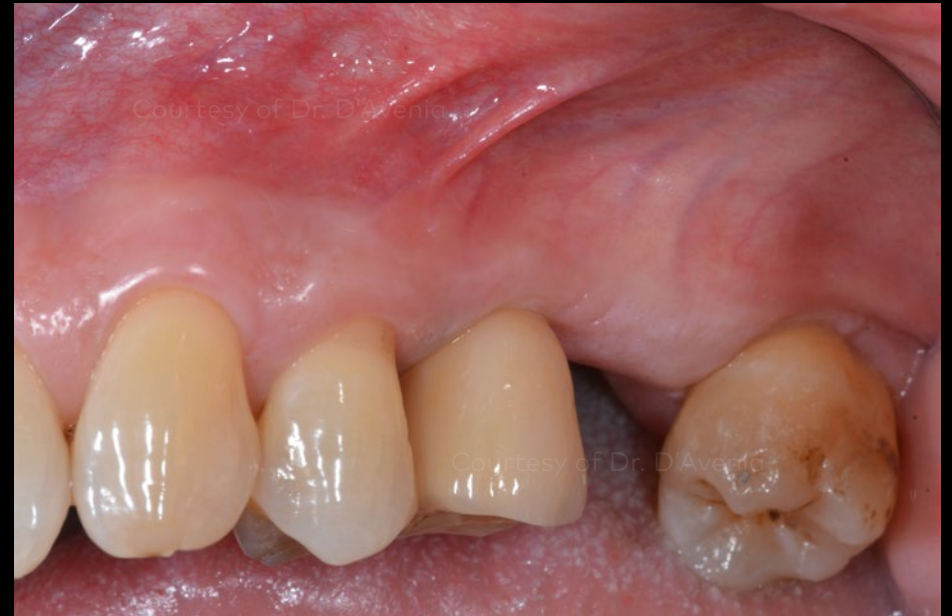
Final restoration.
